DATA SUMMARY

Date and Time	Saturday, May 29, 2010; 11:45 local time
Place	Airdrome San Luis (Menorca)

Enrollment	N-554RB
Type and model	BEECHCRAFT E55 BARON
Exploitative	Private

REPORT

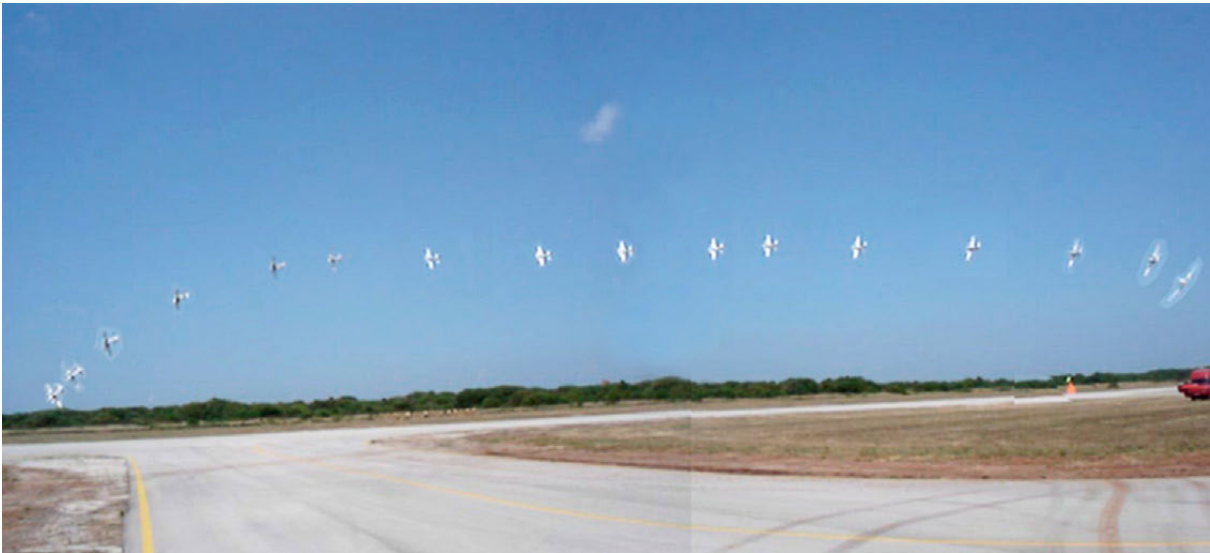
Figure 1. Flight path followed by the aircraft

After takeoff, the aircraft made a left turn to follow the marks ("scatter points") that had the circuit with a height above ground of approximately 200 ft (see Figure 1). Then again turn left to fit the second control points (scatter point) land constituting the test circuit (see Annex 2). In this shift warpage of the aircraft it was very pronounced, close to 90 degrees, and the aircraft plunged to the ground. Then there was an explosion and the aircraft burned.

Actually the turn was not uniform even greater warps observed in steps over the two control points. During the last turn next warpage angles were observed at 90 and as the aircraft lost control and hit the ground.

Figure 1 is observed as the aircraft at the end of his career began to level the wings but was unable to complete the recovery maneuver given the low altitude at his disposal.
